Hydraulic Model Studies of Aeration Enhancements at the Folsom Dam Outlet Works: Reducing Cavitation Damage Potential

by K. Warren Frizell
Research Hydraulic Engineer
Water Resources Research Laboratory

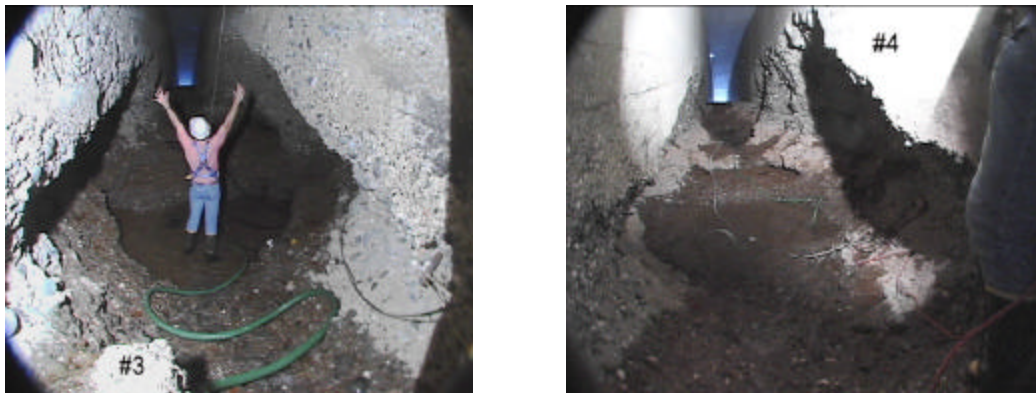
Figure 4: Damage to conduits 3 and 4, low-level outlets, May 1997.

During major releases in the winter of 1996/1997, observers noted that the trajectories of the discharge from outlets No. 3 and 4 were falling short of those from outlets No. 1 and 2. Inspections in May 1997 revealed major damage due to cavitation in outlets No. 3 and 4 (figure 4), minor damage in outlet No. 2 (figure 5) and little or no damage in Numbers 1, 5, 6, 7, and 8.

This damage was initiated by cavitation and accelerated by a combination of both cavitation and abrasion. Abrasion damage is probably primarily responsible for the deep lateral extent of the damage in outlets No. 3 and 4, especially along the construction joints. There was a widely varying degree of damage between outlets 1, 2, 3 and 4. Cavitation intensity is largely a function of pressure and velocity so the variation in damage is attributable to very low localized pressures downstream from the gates due to air starvation. Previous studies show the manifold system is undersized for the expected air demand. Outlets 3 and 4 are at the end of the air manifold that brings air to the conduits.

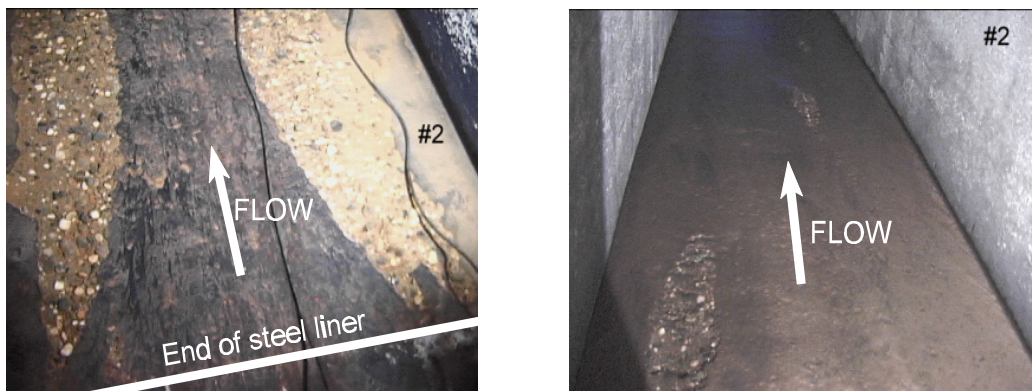
Figure 5: Damage to invert of conduit 2. Left photo is at the end of the steel liner. Note the pattern of damage on the right photo.
